# WELL HEAD TECHNOLOGY

## The Sealant for Well Head Leaks

### VB® Wellhead Sealant

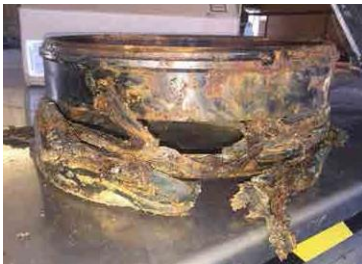
**VB® sealant** is a new, innovative product designed to effectively seal flange leak, neck seal leak and void pack-off leak of tubing and casing hanger elastomeric seals preventing continuous communication and pressure increases throughout the void area.  
After sealing, future wellhead dismantlement is easy.

Sometimes (due to age, chemical exposure, temperature variations or possible damage during installation) seals can be damaged, and VB® sealant will seal the damaged or failed elastomers as well as leaks in pitted, de-formed and scarred metal.

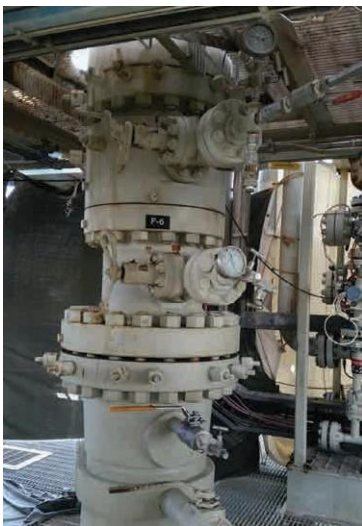
- The product eliminates communication and pressure fluctuations throughout the void areas.
- The material is delivered through NNW proprietary delivery system, maintaining a safe work environment for all personal involved.
- It is a complex, dry polymer blend that is mixed on site and administered through existing valves or ports on the well head.
- After injection, it is recommended to let the sealant cure for a minimum of 8 hours > 60F and 12 hour < 60F.

**VB® Sealant does not require differential pressure to set/cure thus allowing the pressure to be bled to 0 psi, post testing.**
